Wrangell Junkyard Cleanup

**Innovative Remediation Technologies
Wrangell Junkyard site Cleanup
Wrangell, Alaska
October 6, 2016**

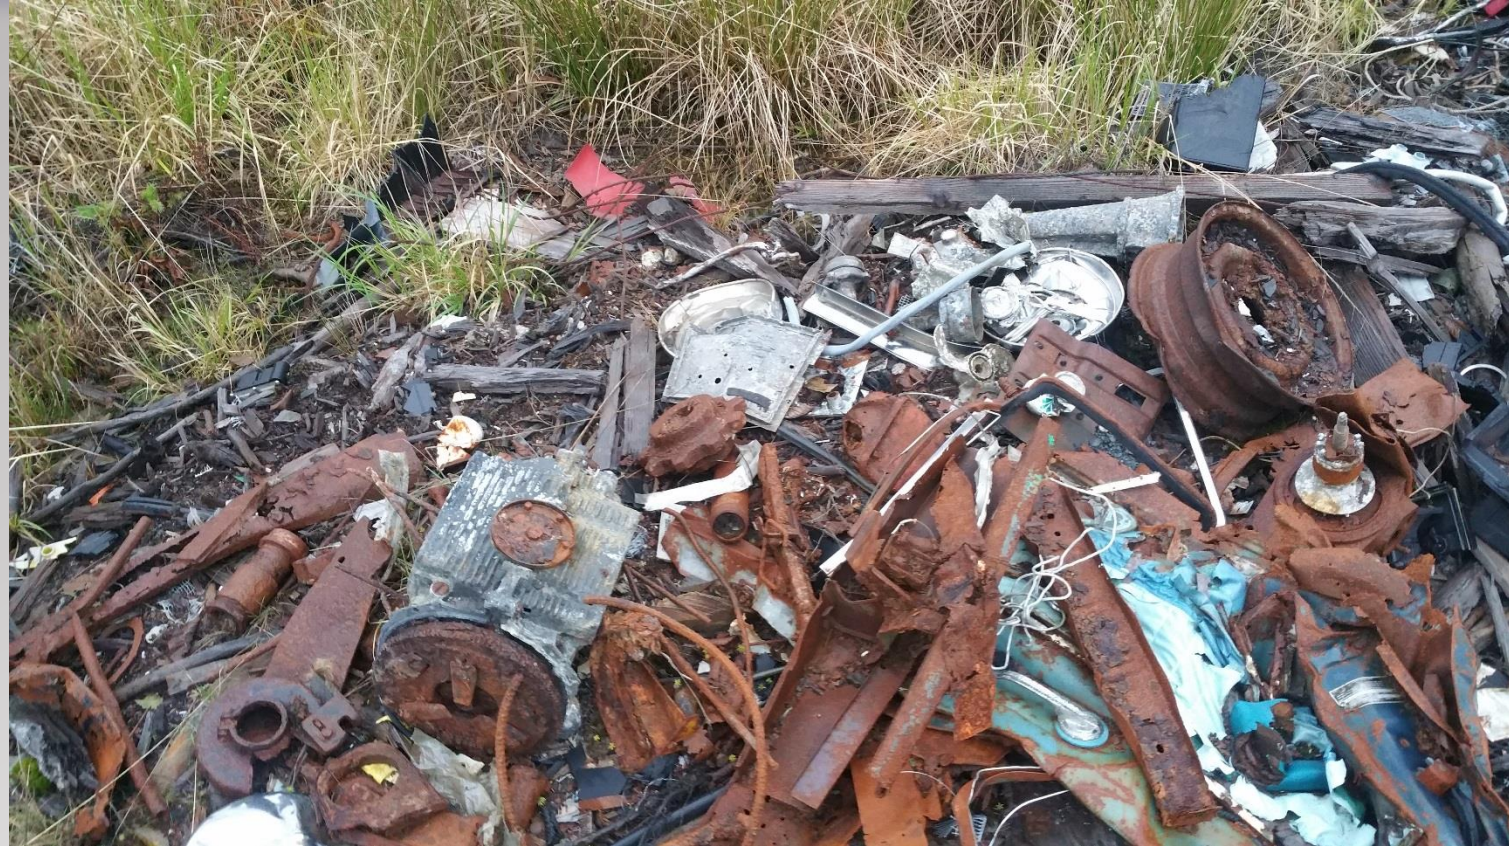
- Depth of Contaminated Soil is Estimated at an average of 3.5 Feet
- Similar to E&E Test Pits Instead of E&E Hand Borings
- E&E Assumption of Bedrock Depth Inaccurate
- Contamination Extends to Underlying Till Layer throughout majority of Site

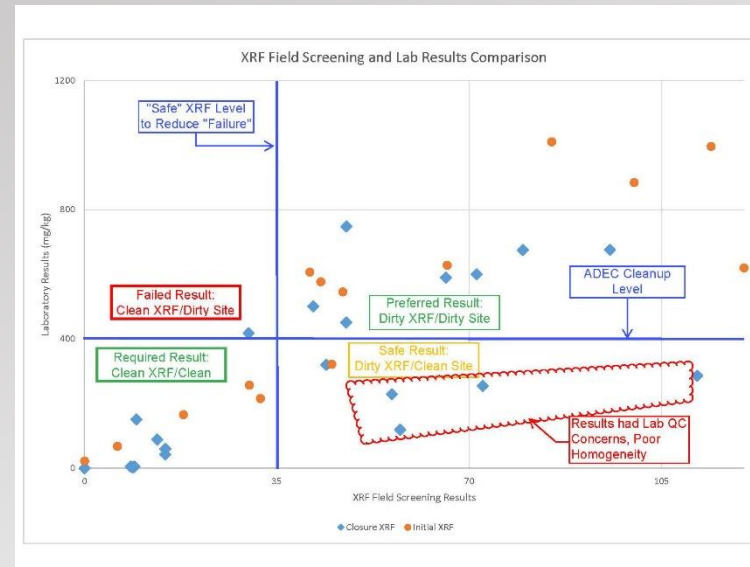
Extensive Lead Contamination

- Batteries and battery fragments were found throughout the soil matrix

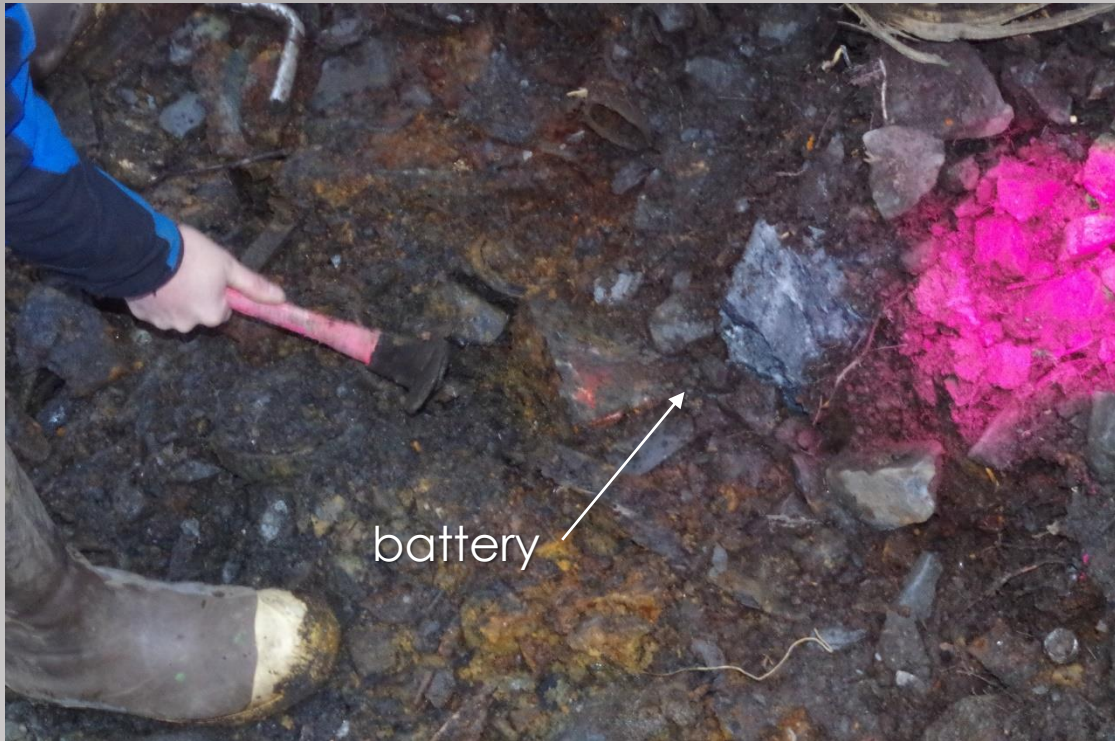
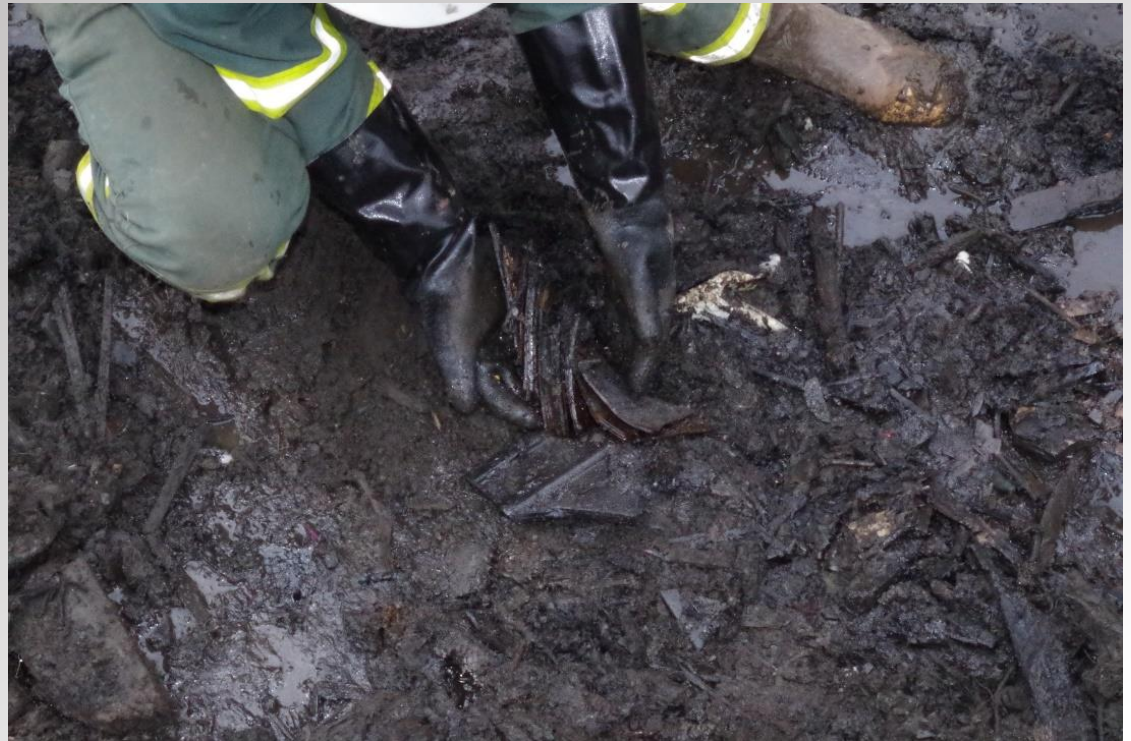
Lead Contamination Existed at Depth

- Excavation work to construct road through Area A noted depth of lead, POL and assorted automotive debris extends to the till layer at depths ranging from **3 to 5 feet**.
- Excavation work and test trench on Area B noted contaminated material ranging from **3 to 6 feet** to the till layer
- Excavation work to construct the pad for the screen plant on Areas C & D also noted contaminated material extends to till layer at **3 to 5 feet**.

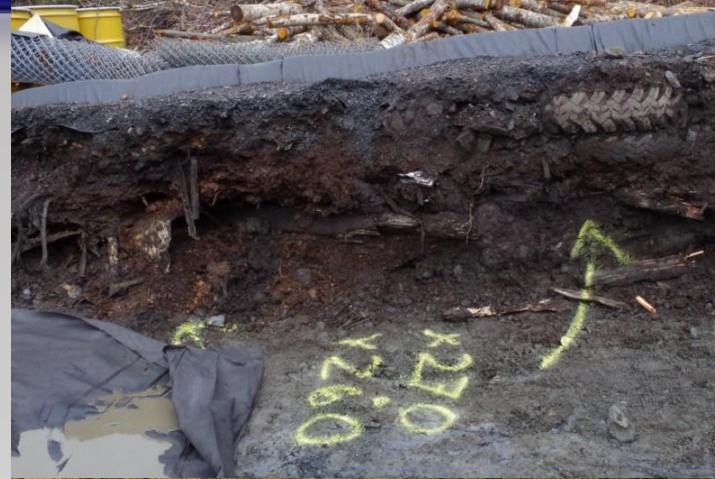
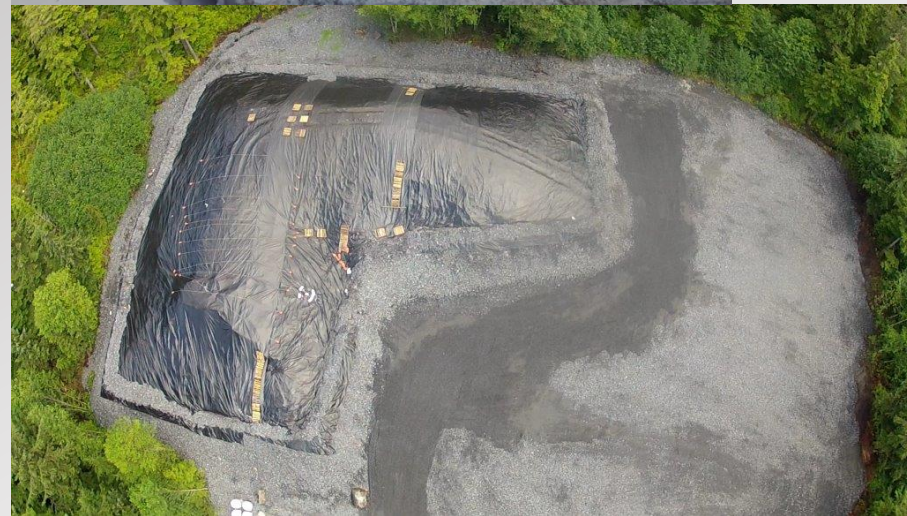
- Lead Contamination Present in Surface Soil/Organic Layer
 - Surface Soil/Organic Layer was disturbed or otherwise churned to Till
 - Till Depth Ranges from 2.5 to 5 Feet (Average is 3.5 Feet)
 - Mixed Lead, POL contamination and Car Parts Throughout
- Original Estimate: 4,000 CY
- Revised Estimate: 16,500 CY
- Actual Quantity: 18,300 cubic yards of stabilized contaminated soil was left stockpiled at the Site

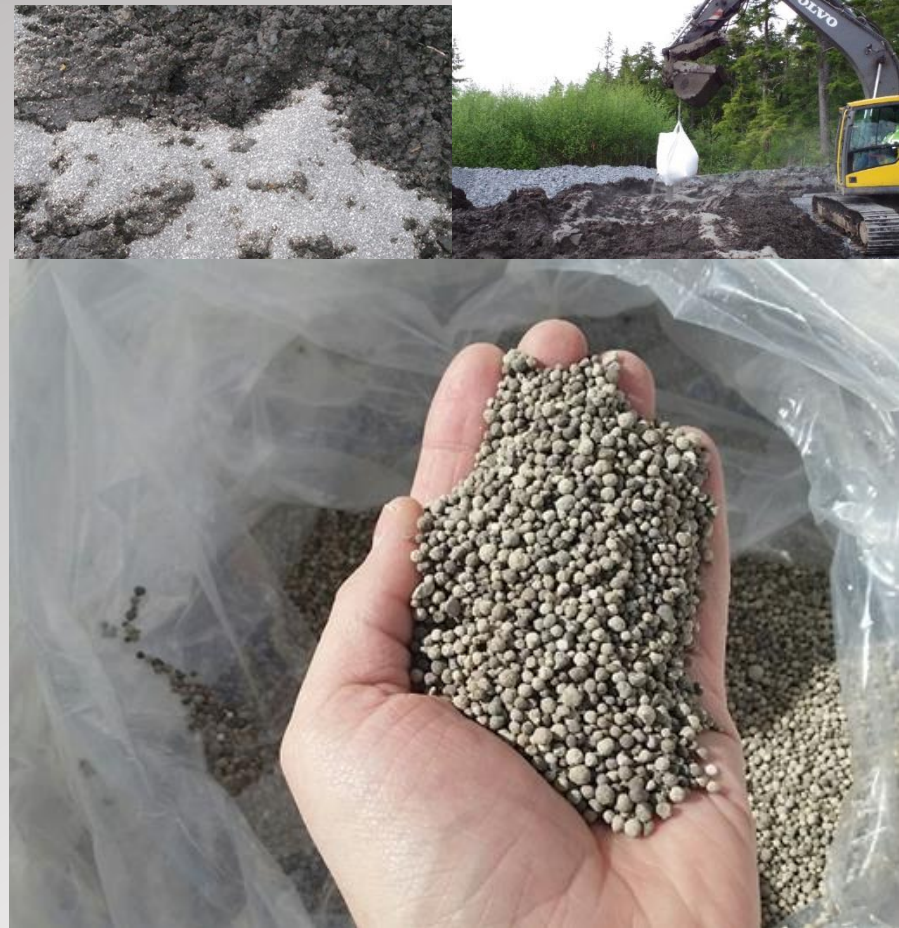
- Excavate and Stabilize Lead Contaminated Soil
- All Soil Above 400 mg/kg Lead Treated with ECOBOND to Reduce/Eliminate Lead Leachability
- Creation of a secure stockpile to be left on-site for future move to a local monofill.

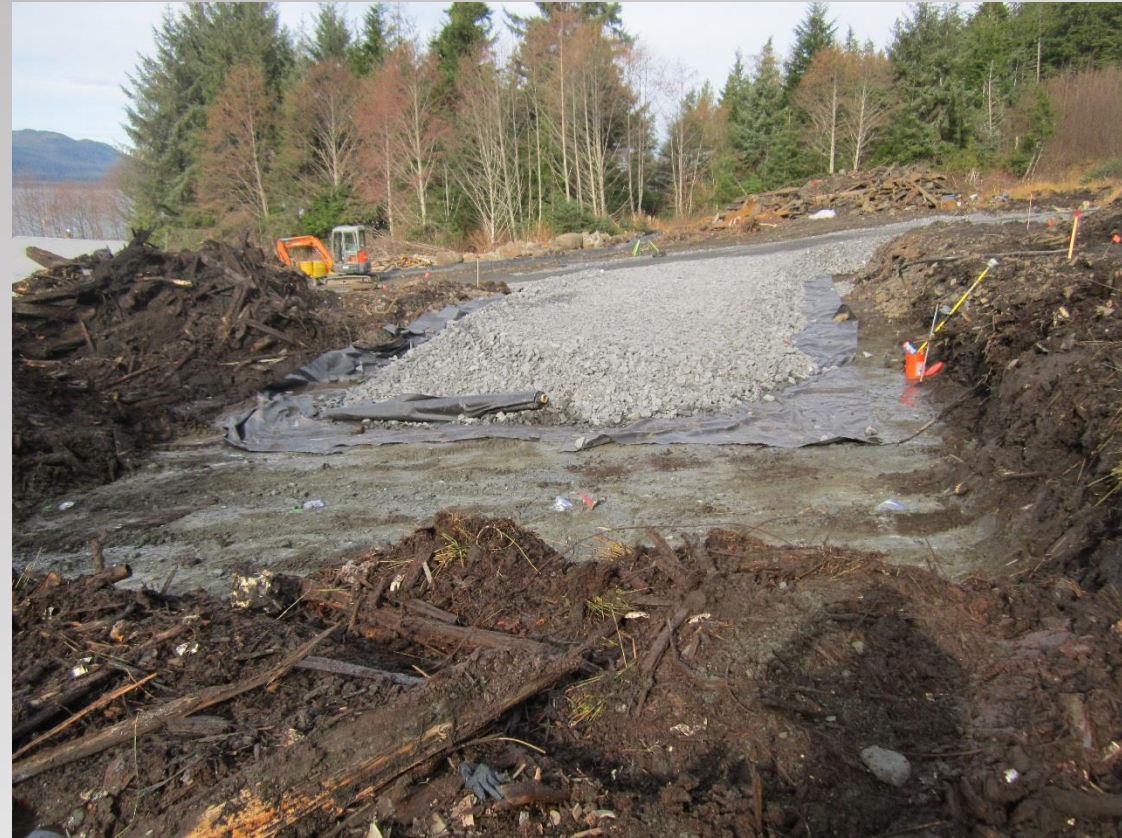
- Project divided into four main areas during Site survey prior to work
- The project site has been mapped using GPS
- Project maps are updated daily
 - Sample and site progress map
 - SWPPP BMP Map

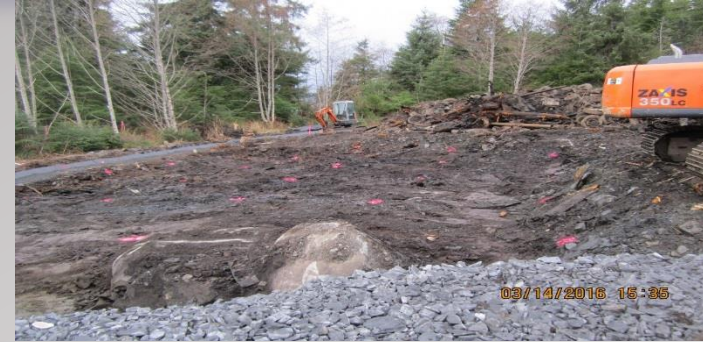
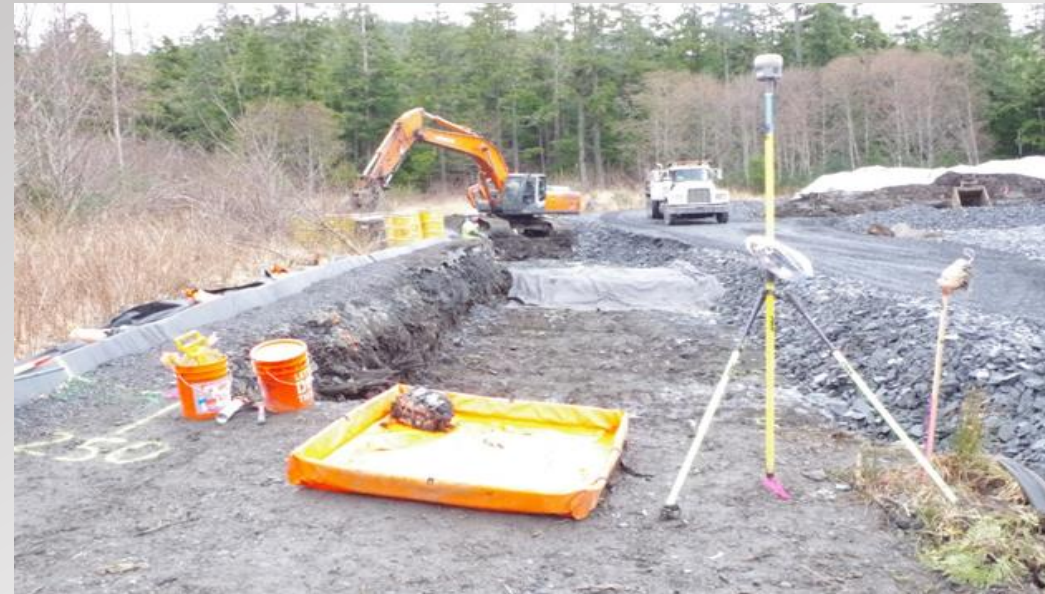
- The Site was mapped using a Trimble TSC3 GPS surveying unit with base station
- Excavation done in one foot lifts, with samples collected for field screening at 10' grid nodes
- If field screening displays positive results for lead or POL contamination, the excavation is advanced another foot in depth in that area

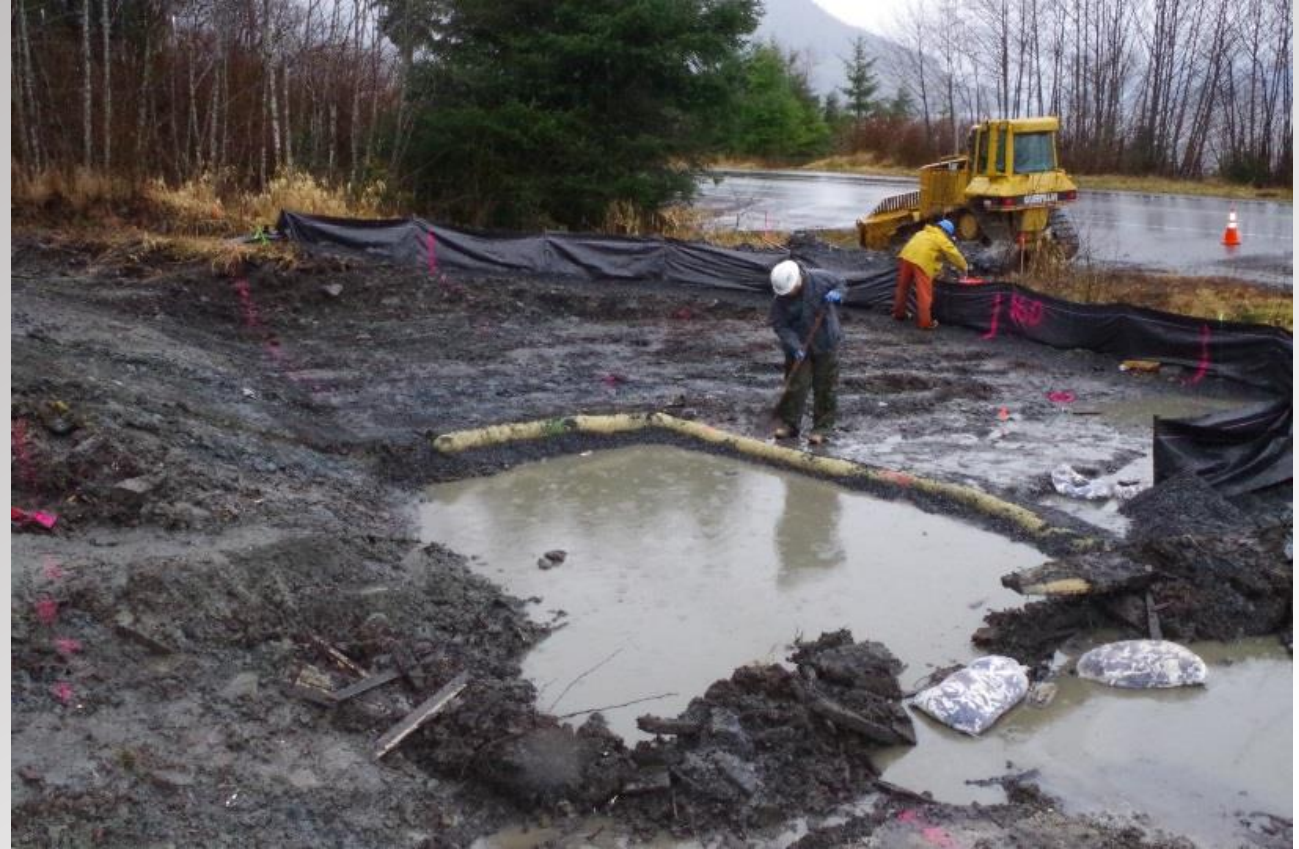
- Installed SWPPP BMPs to Manage Runoff
- Setup Water Handling Areas
- Processed nearly 115,000 gallons of water for surface discharge

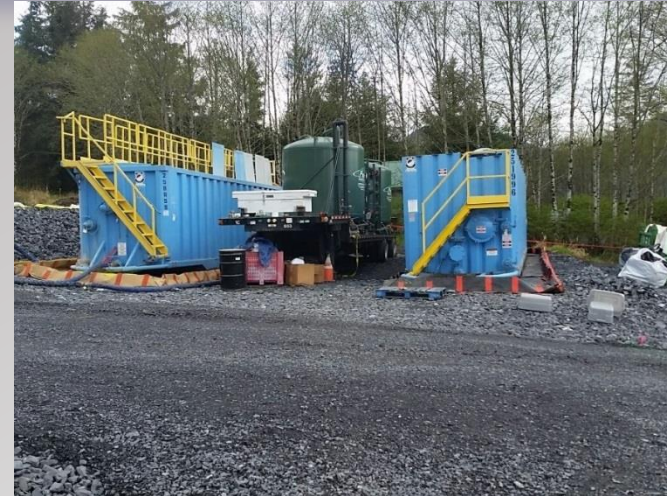
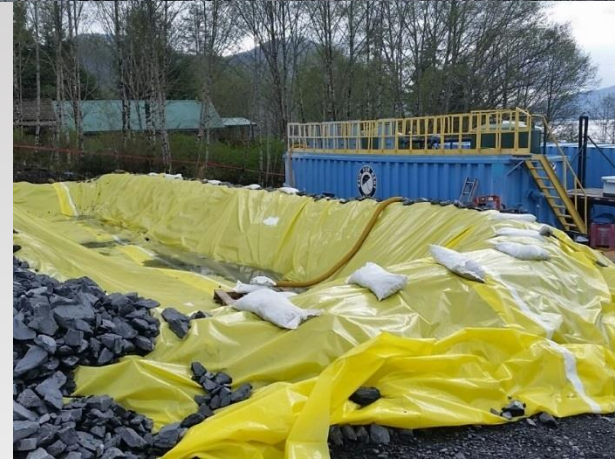
Project Approach

- Construct Capture/settling trench
- Set up Settling tank
- Filters – zeolite and carbon
- Post treatment holding tank and test prior to discharge

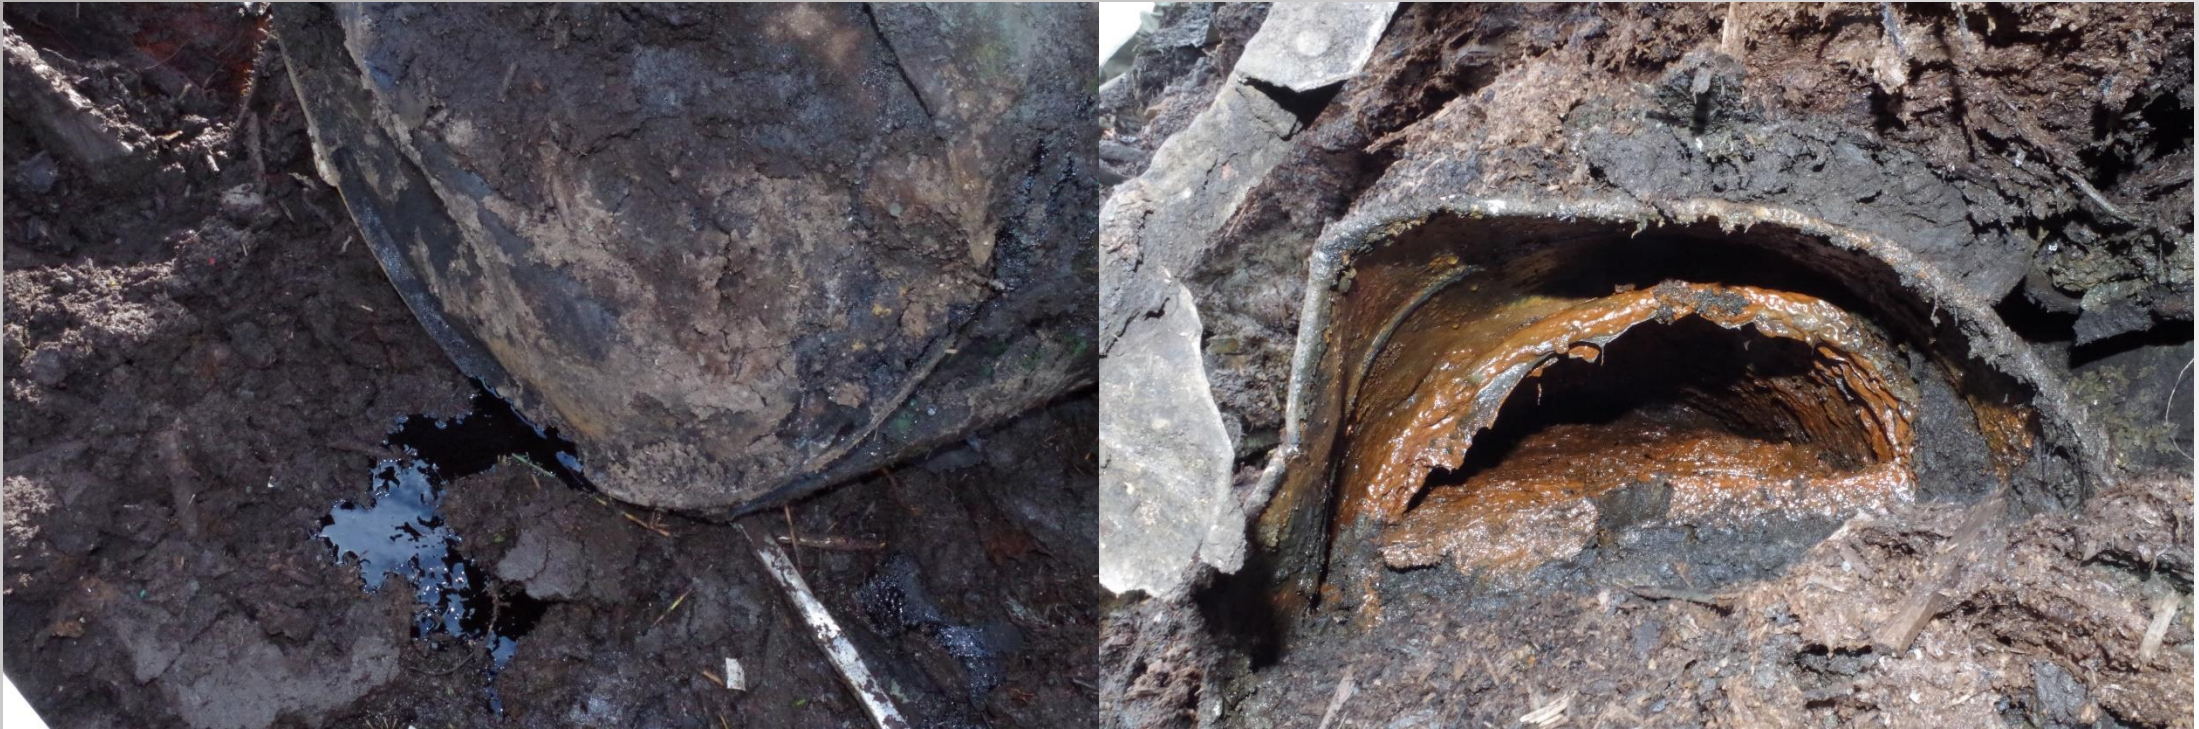
Petroleum Contamination

- Petroleum contamination was present in roughly 5-8% of the excavated material
- Subsurface crushed drums containing petroleum were located

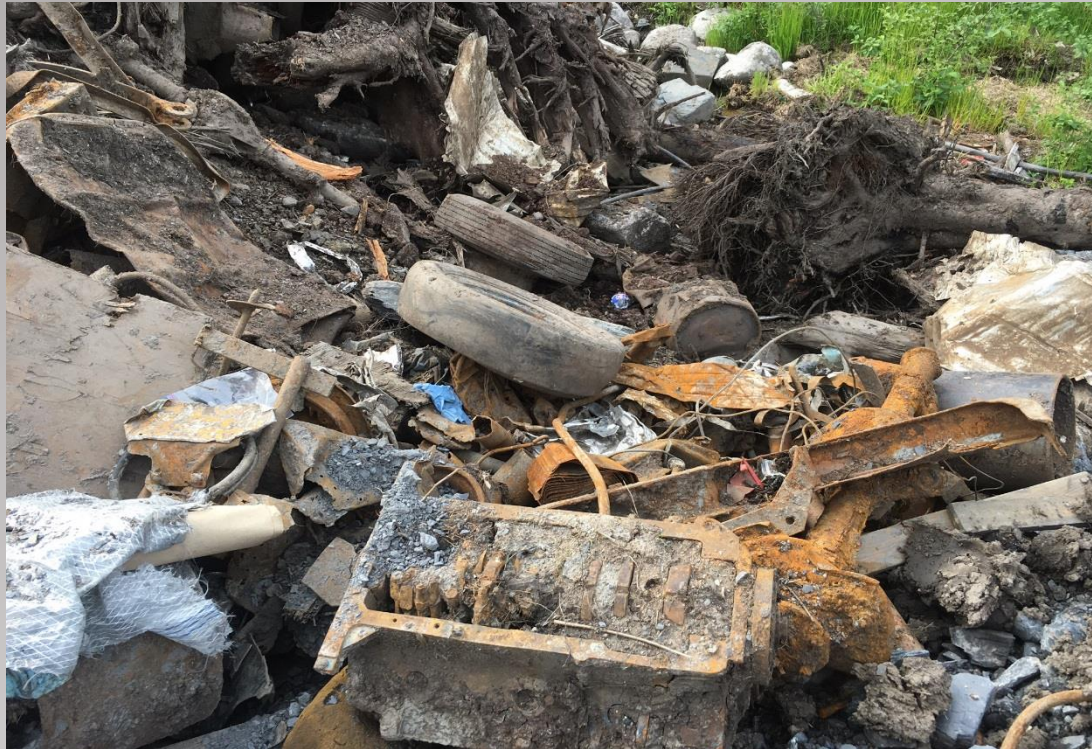
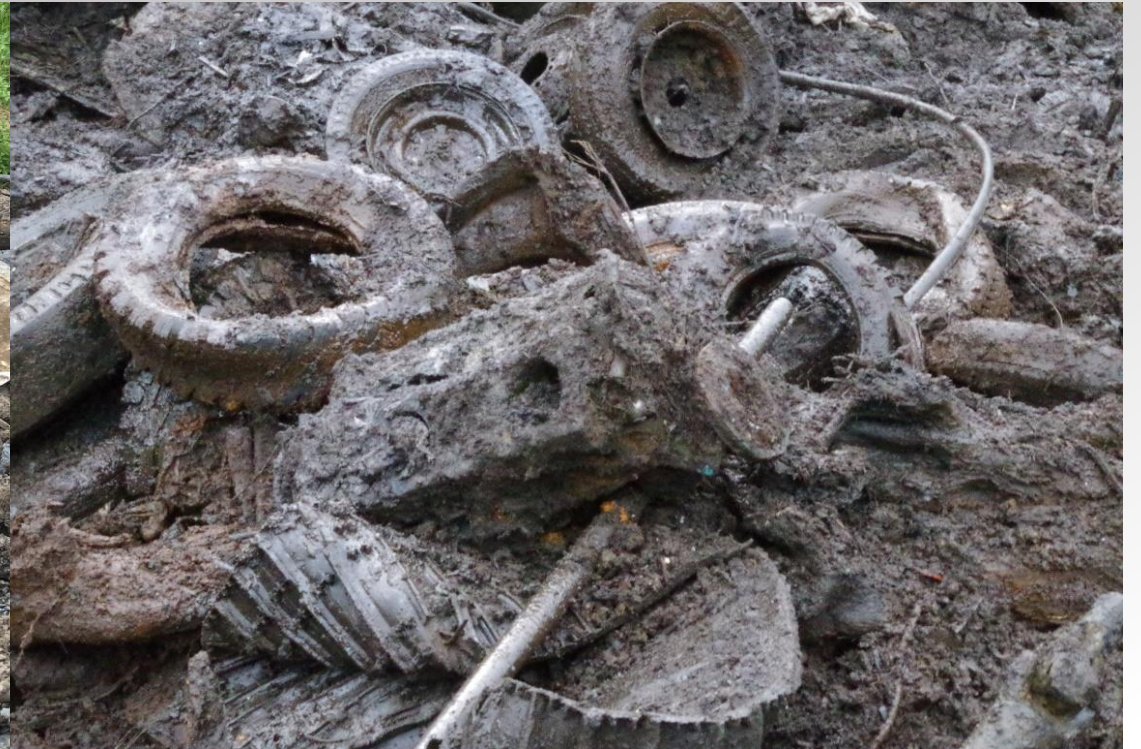
Extensive Debris

- Debris, including automotive, industrial and marine engines and parts and tires was present throughout the site, throughout the soil matrix
